California State Board of Equalization
450 N Street, Sacramento, California

Mold Remediation – 7th Floor
June 23 – July 16, 2010
Closure Report
Project No. 2372.02-572

Report Date:
August 10, 2010

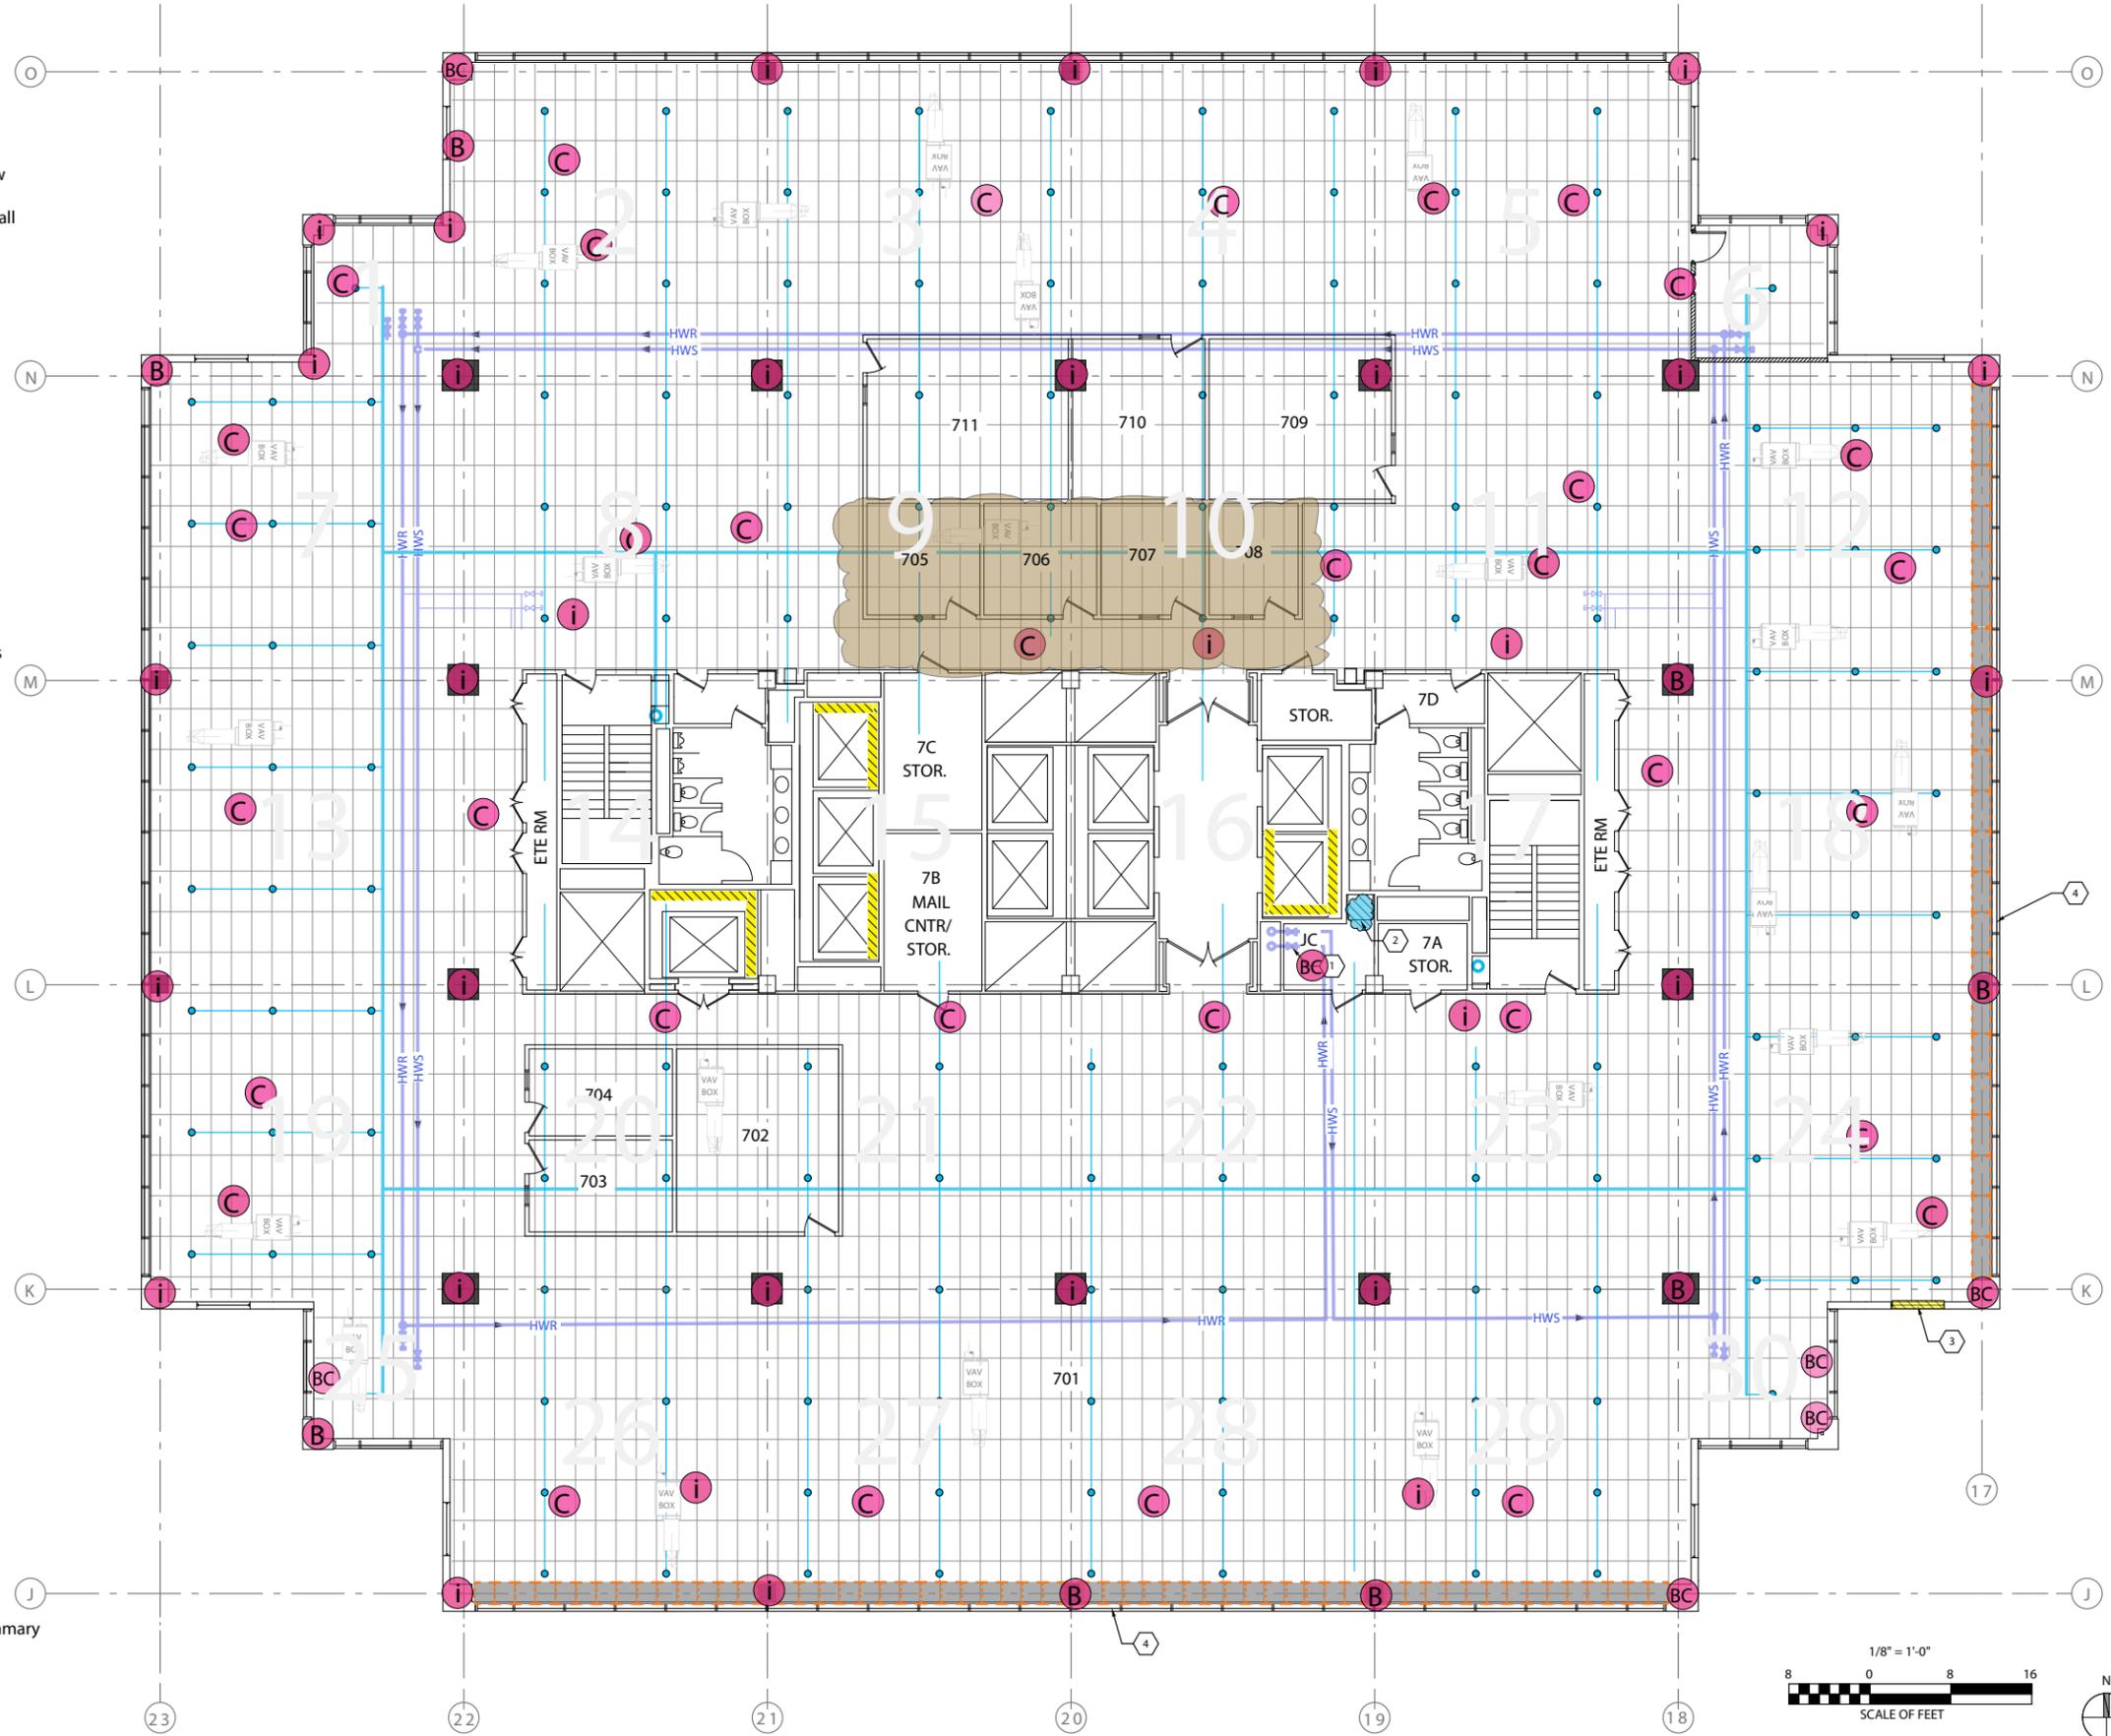
Figure 1 Water Damage Assessment Revised

- ① Rusty valve, water stain (current)
- ② Standing water on floor
- ③ Water stain on punch-out window
- ④ Water intrusion prior to curtain wall repair in 2005

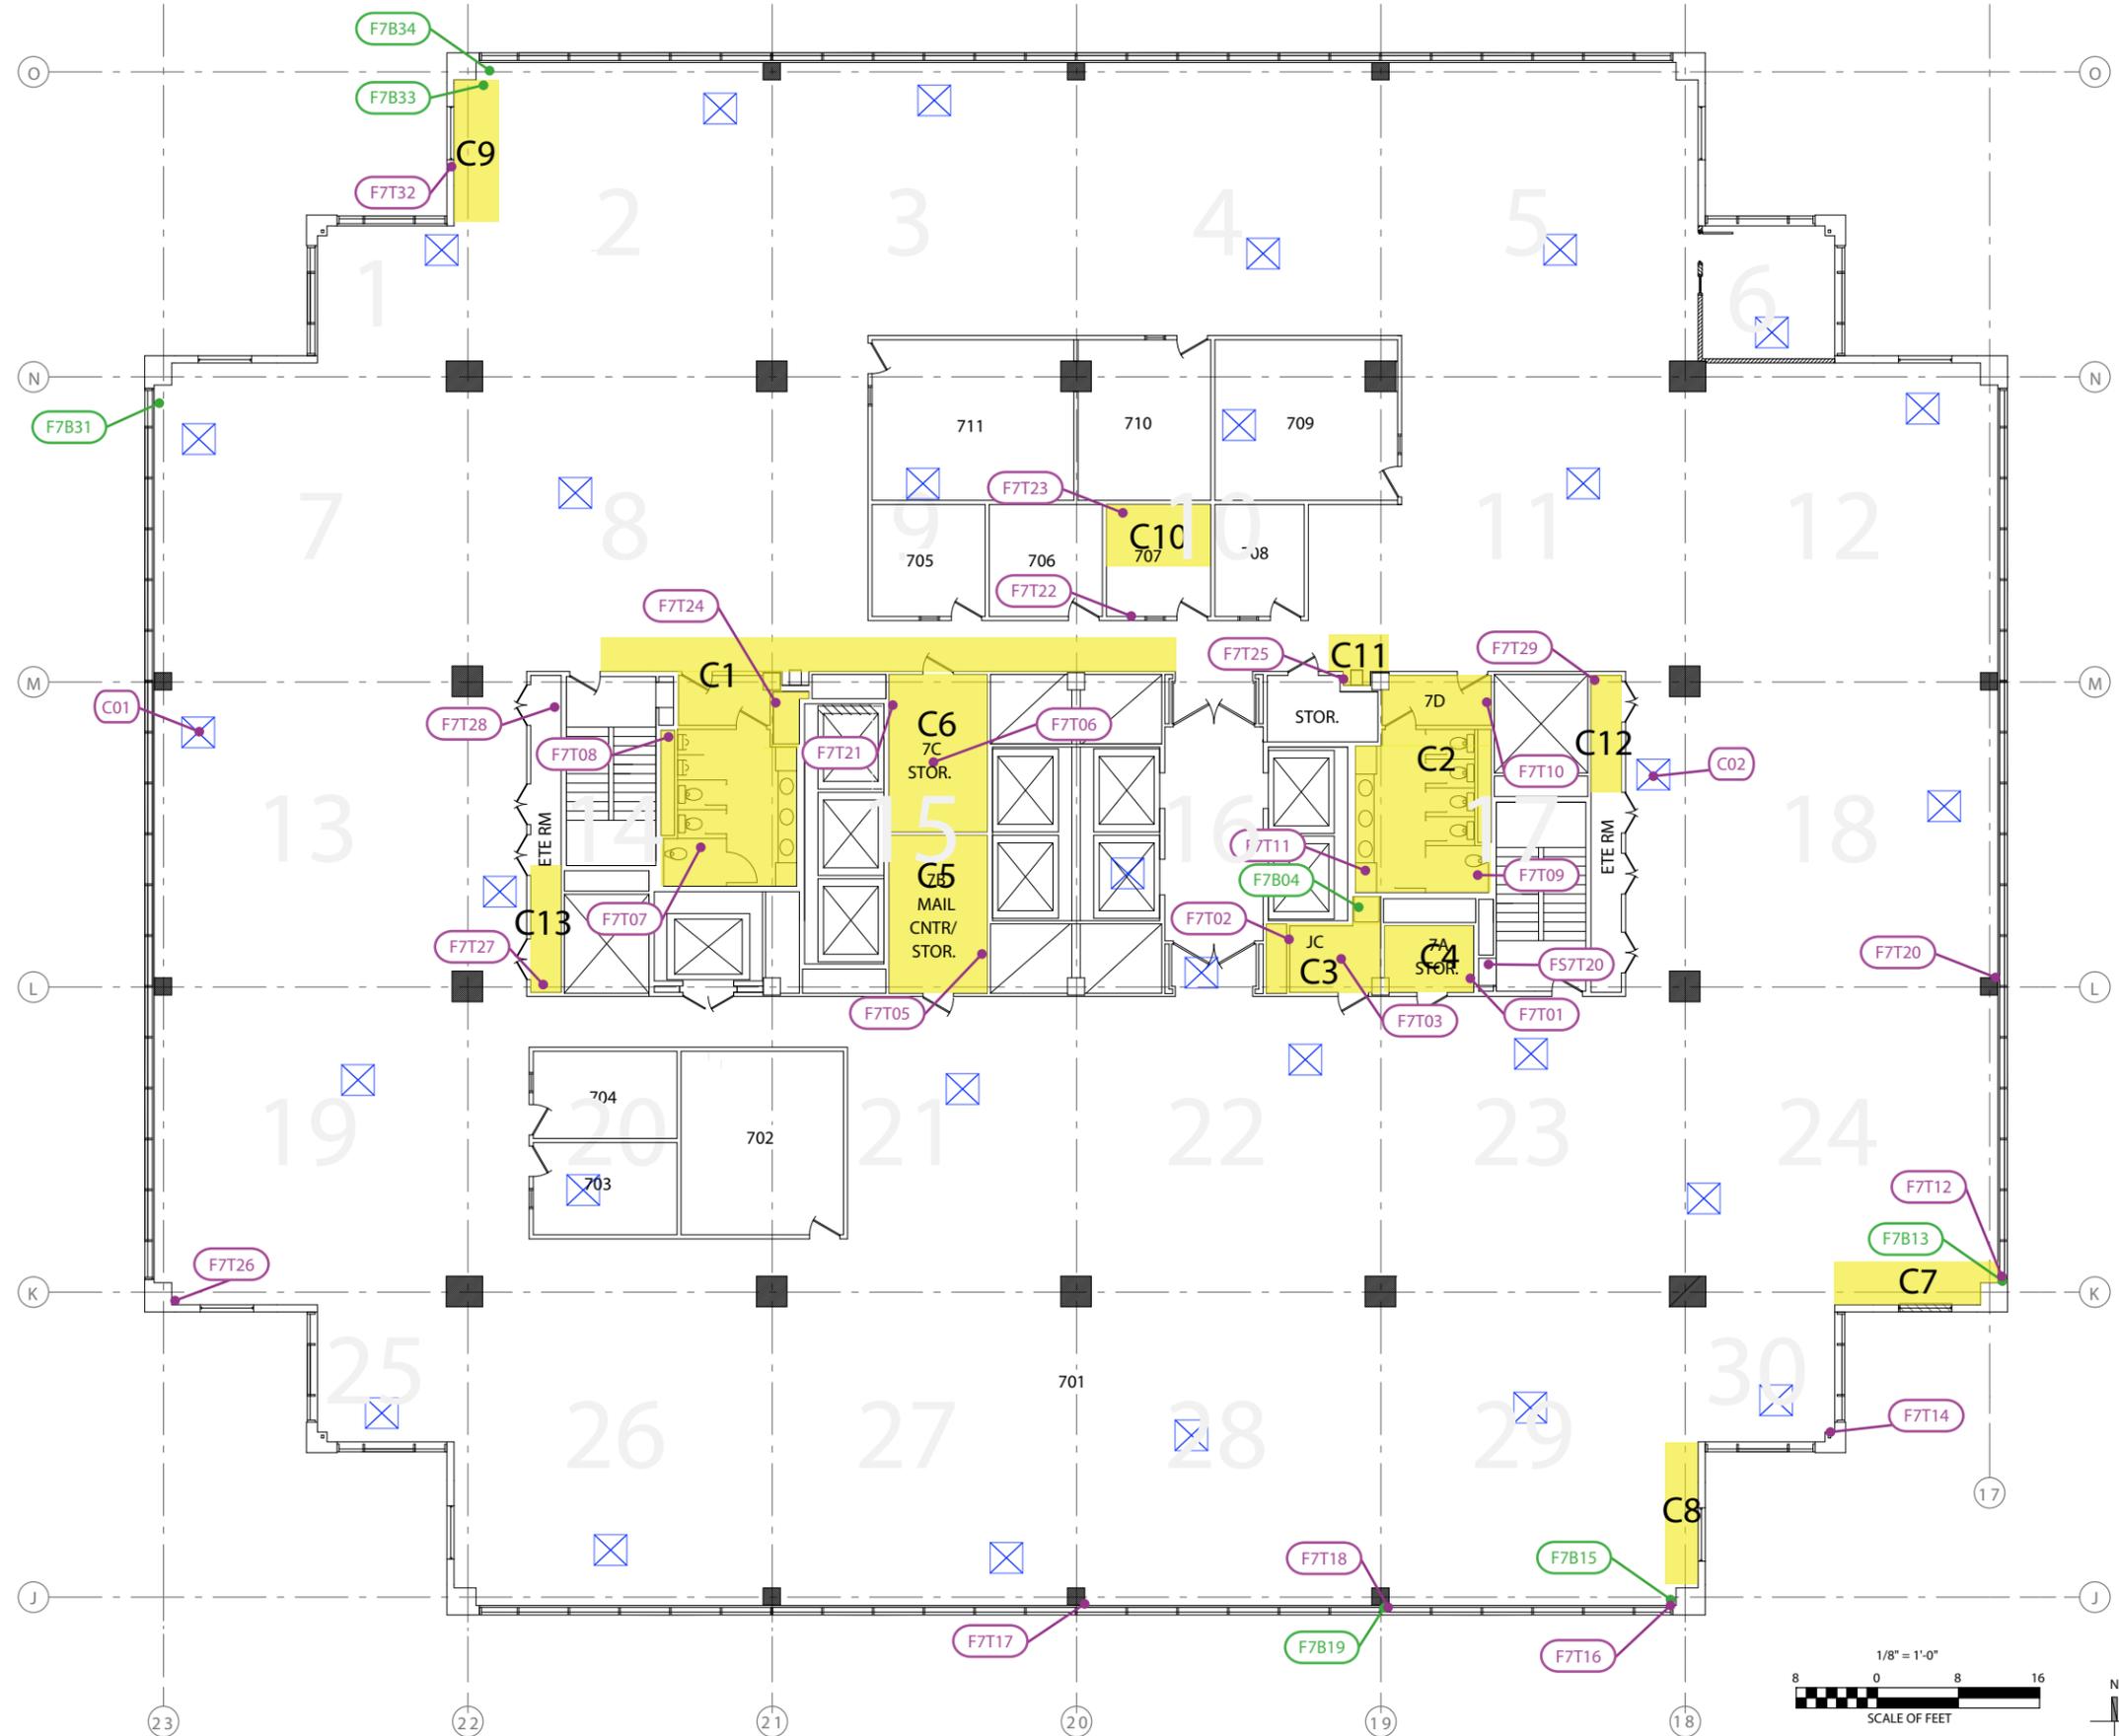
Figure 2 Containment and Sample Locations

Identified areas were subjected to sampling. Using a combination of surface tape lift and bulk samples, LCD tested stains on walls and other building materials to determine if the stains were indicative of VMG. The sample locations are depicted in Figure 2.

Areas and materials that were identified to contain mold growth were subsequently placed under containment and subjected to an appropriate mitigative or remedial action. Ceiling areas above the rooms (e.g., men's restroom and storage rooms) located in the building core (adjacent to the northwest stairwell) showed large areas of VMG. These areas of above ceiling VMG are believed to be interstitial moisture that resulted from the Floor 9 flood that occurred in March 2009. These actions were taken to eliminate or minimize potential exposures to

VMG by personnel that may later access the subject area. The containment locations are shown in Figure 2.

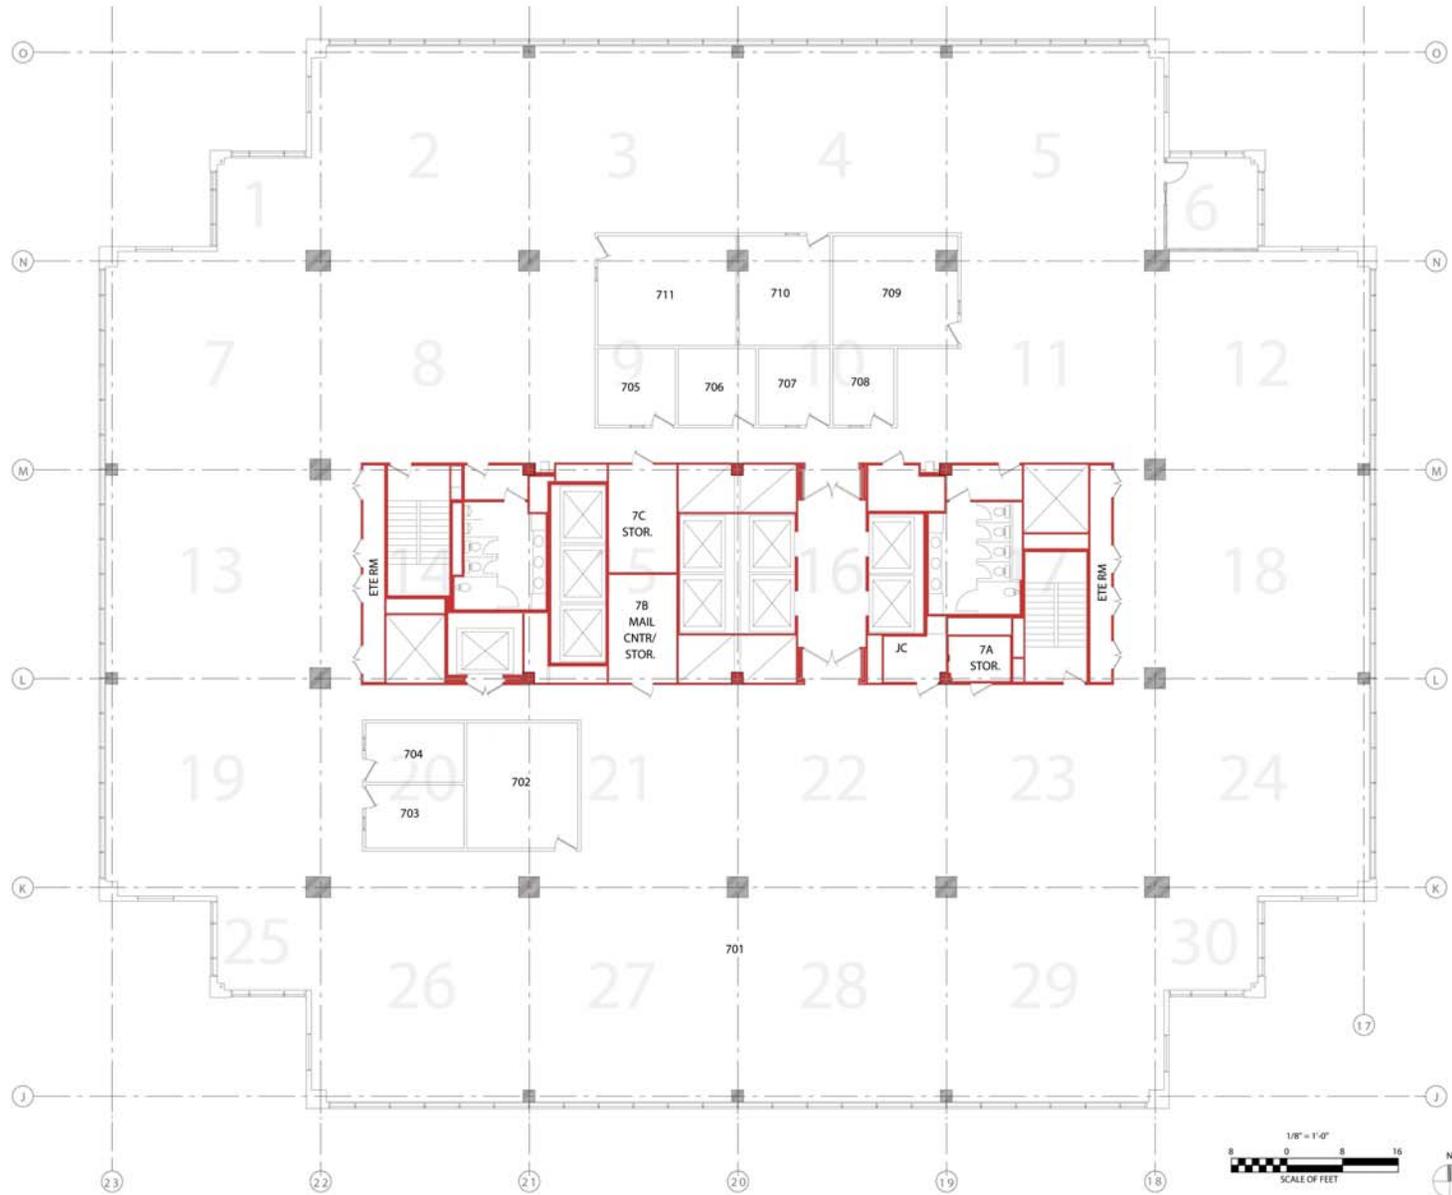
Figure 3

Suspect Mold - July 2010
Board of Equalization Building, Mold Remediation
450 N Street, Sacramento, California
