APPENDIX A – PHOTOGRAPHS

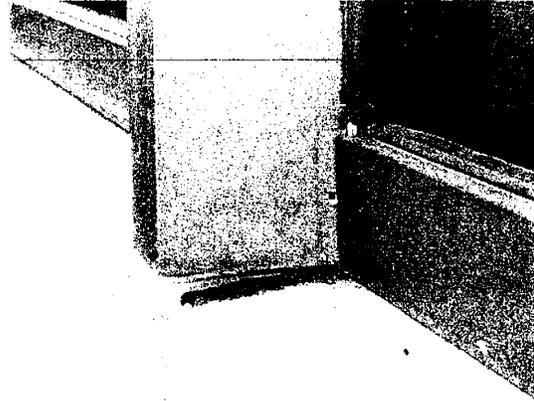
Photo 14 – South elevation, gasket at corner not continuous.

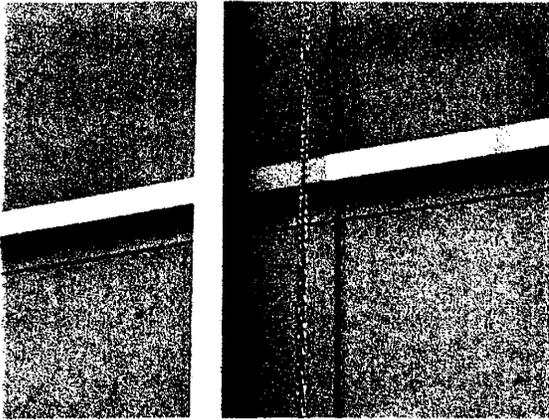
Photo 15 – East elevation, gasket at corner failed.

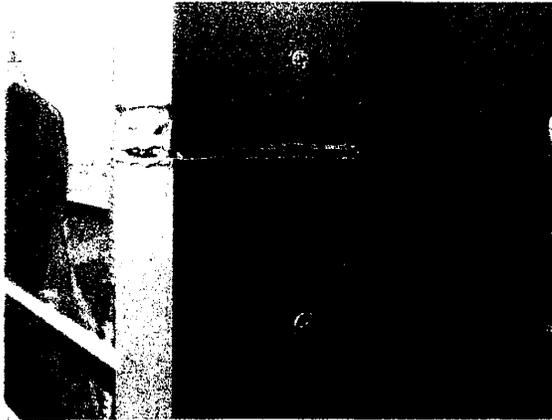
Photo 19 – South elevation, failed sealant at vertical mullion splice joint.

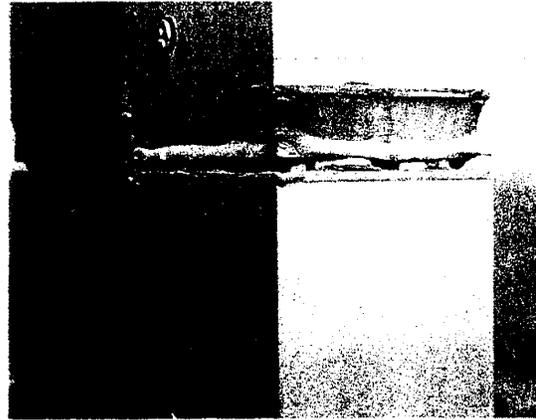
Photo 20 – South elevation, failed sealant at vertical mullion splice joint. Fastener at top not fully engaged or caulked.

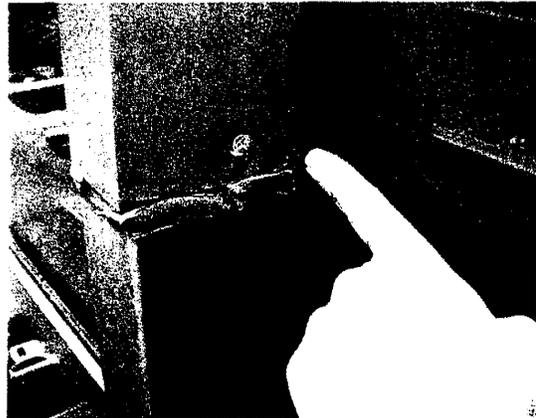
Photo 22 – South elevation, failed sealant at vertical mullion splice joint.

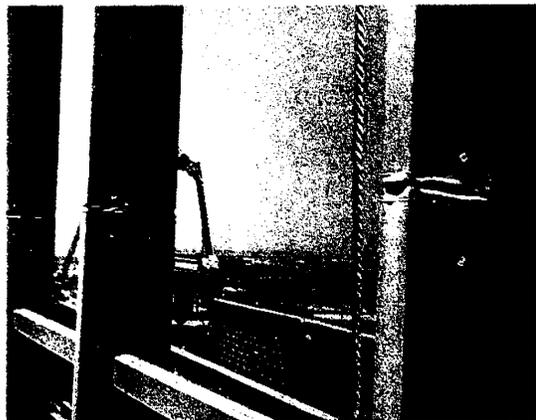
Photo 24 – South elevation, failed sealant at vertical mullion splice joints.

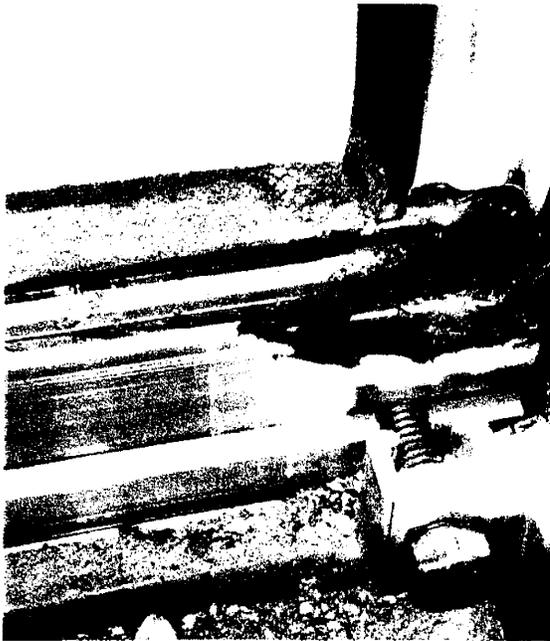
Photo 33 – Water in track. Water drop at bottom of vertical frame.

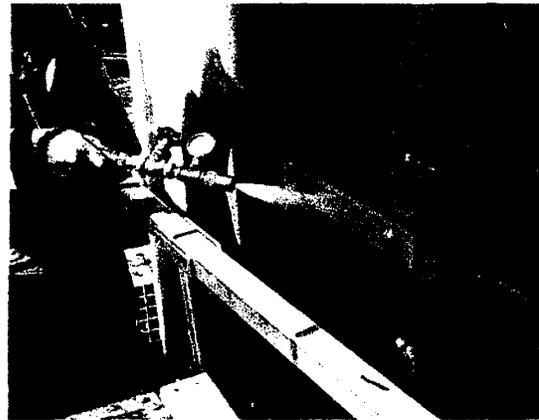
Photo 34 – Test #7. Spray directed at horizontal beauty cap/vertical mullion joint.
