**Post Mitigation Assessment Report**  
**Department of General Services**  
**Board of Equalization Building, 450 N. Street**  
**Break Room 807 and 22<sup>nd</sup> and 23<sup>rd</sup> Floor Hopper (Janitor) Rooms**  
**Sacramento, California**

August 27<sup>th</sup>, 2008BOE Building Break Room 807/805 and 22<sup>nd</sup> and 23<sup>rd</sup> Floor Hopper Rooms Areas  
450 N Street, Sacramento, CA[Click here for color photos](#)

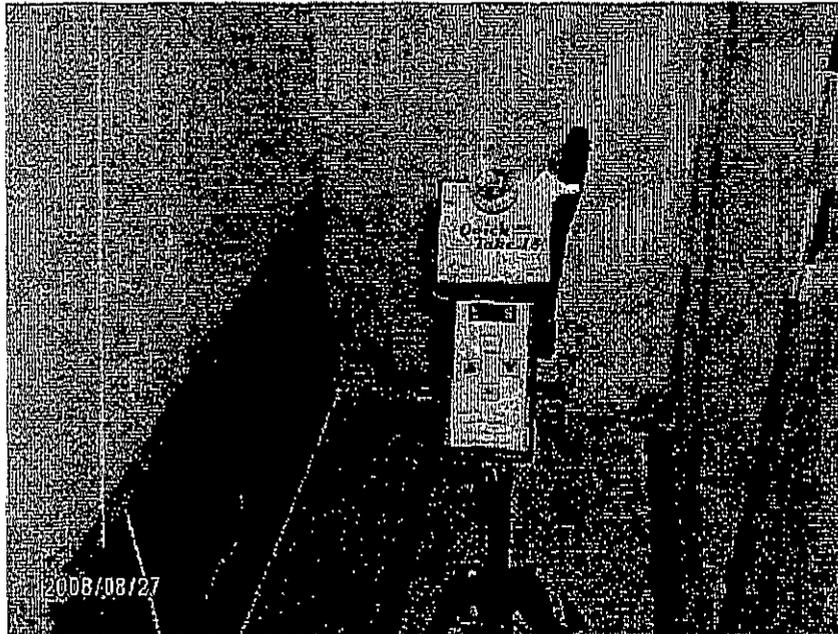
3) Image of air sampling equipment and wall removal within mail center room adjacent to 22<sup>nd</sup> floor Hopper Room area at time of assessment.

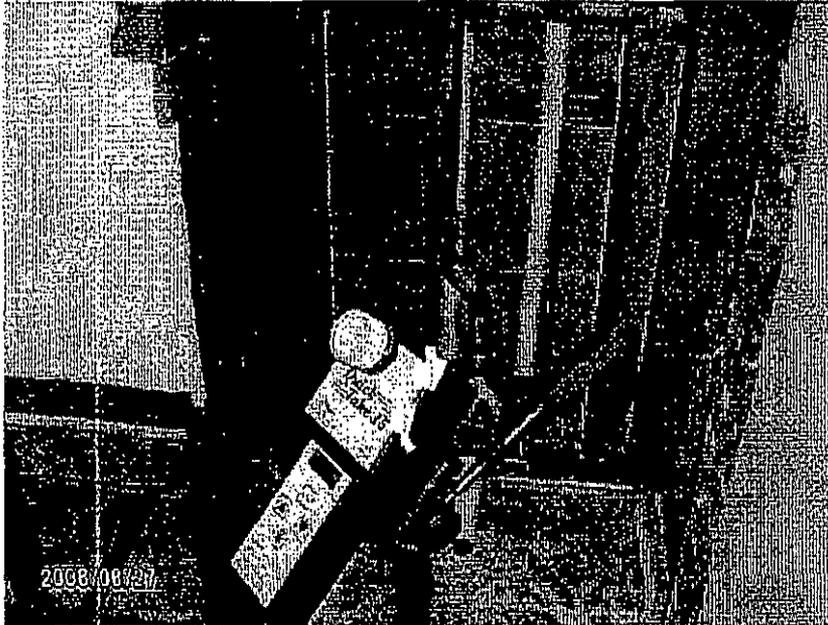
5. Primary affected areas of visible moisture damage previously identified within the noted Hopper Room areas primarily consisted of moisture staining and mold damaged materials within and adjacent to the wet-mop sink areas and adjacent flooring, and wallboard materials. According to BioMax's review of current evidence and available historical data, it is likely that such material damage were similarly caused by a history of chronic plumbing deficiencies and water release events over an extended period of time.

- 5) Image of air sampling equipment and area material removal adjacent to wet-mop sink unit within 23<sup>rd</sup> Floor Hopper Room at time of clearance assessment.
