APPENDIX A – PHOTOGRAPHS

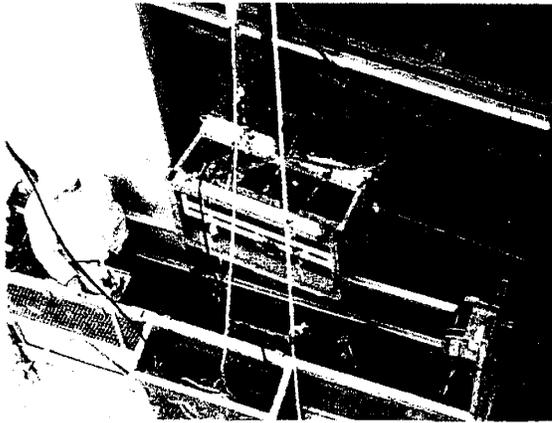
Photo 31 – East elevation, near south end of head of vision glass at Floor 21. Differential pressure water test chamber installed.

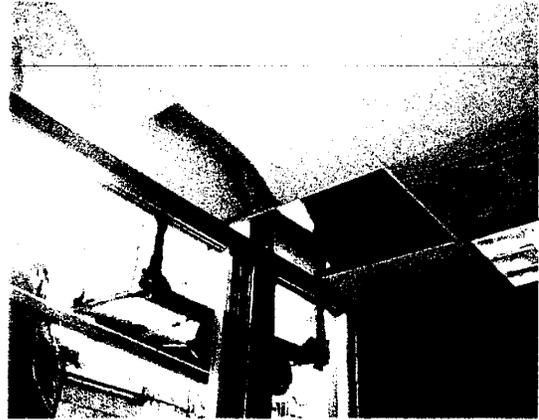
Photo 32 – Interior view of test chamber at head of vision glass at Floor 21, east elevation near south end.
